# NFLA Policy Briefing No.203

Date: 20<sup>th</sup> July 2020

Subject: Investigation of 'near miss' incident between the passenger ferry 'Stena Superfast VIII' and a submerged Royal Navy nuclear powered submarine in the Irish Sea

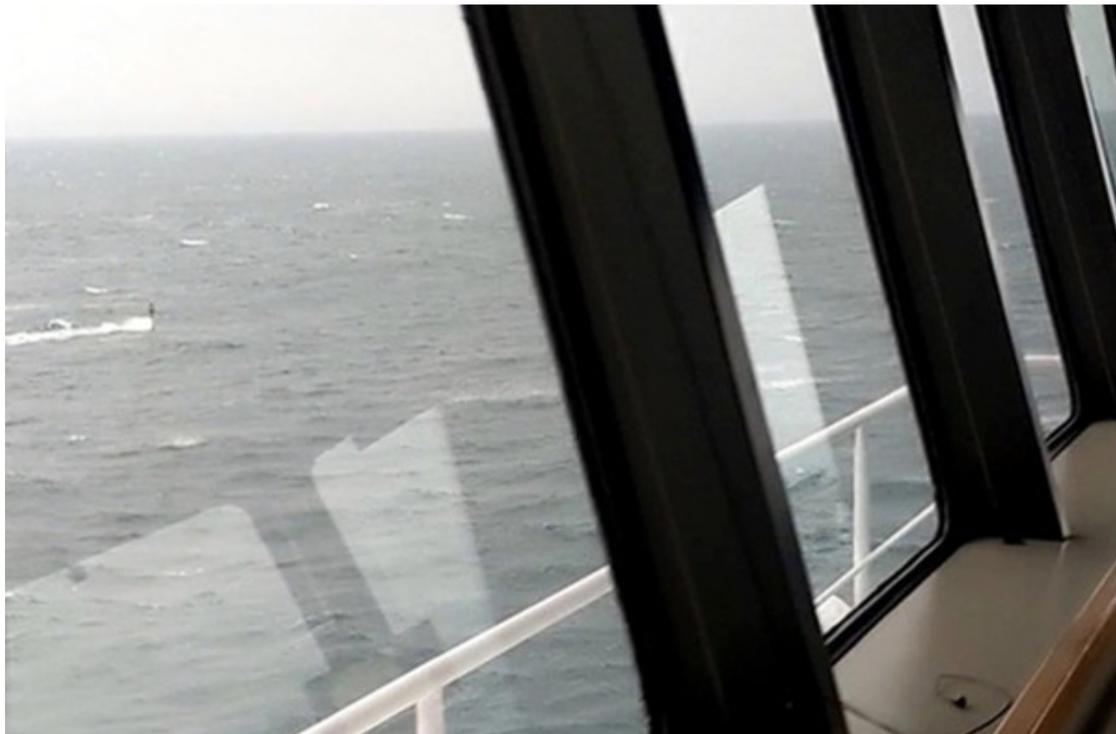
At about this time, Stena Superfast VII's lookout spotted a submarine periscope close on the port bow, and alerted the officer of the watch, who took immediate action (a rapid change of course away from the periscope) to avoid collision. After taking such an avoiding action, the ferry's crew (based on their photographic and visual evidence) reported that the closest point of approach with the submarine was about 250 yards, which was clearly unsafe and constituted a "near miss" scenario.

The MAIB analysis agreed with the ferry crew's report and concluded that the close proximity/near miss incident had occurred because the submarine's control room team overestimated the ferry's range and underestimated its speed. ***This combination meant that the submarine's commanding officer and its officer of the watch made safety-critical decisions that might have appeared rational to them at the time but were actually based on inaccurate information.***

**View of the submarine's periscope and wake from the Stena Ferry's bridge (source: taken from the MAIB inquiry report):**

The Royal Navy has taken a series of actions in response to this incident, and previous similar accidents. As a result, the MAIB report makes a safety recommendation to the Royal Navy to undertake an independent review of its actions taken "to ensure that such actions have been effective in reducing the risk of collision between dived submarines and surface vessels."
